BRAND STATUS UPDATE

BRAND PROJECT

BRAND DIGITAL FRONTEND

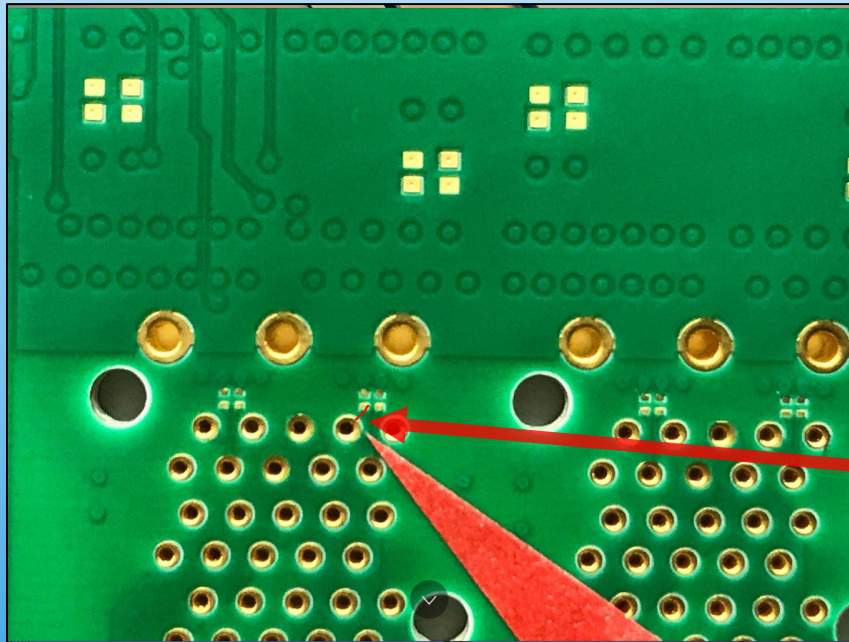
Production of PCB board by Chinese manufacturer

- Challenging due to large size, large number of layers, high-currents
- Production of 6 boards: 1 x functional, 1 x minor defects (fixed), 4 x defective

Etching issue (missing lane)

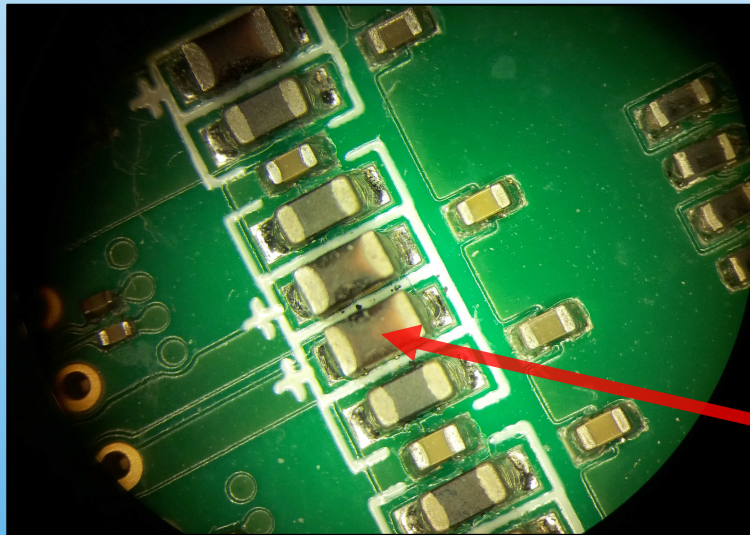
Soldering issues found (could be fixed in-house):

Underheating in some areas of the PCB

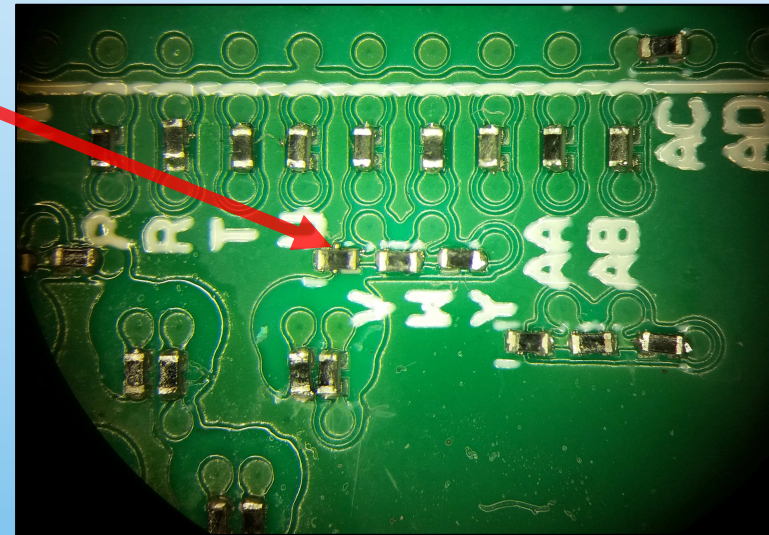
Overheating in some areas of the PCB

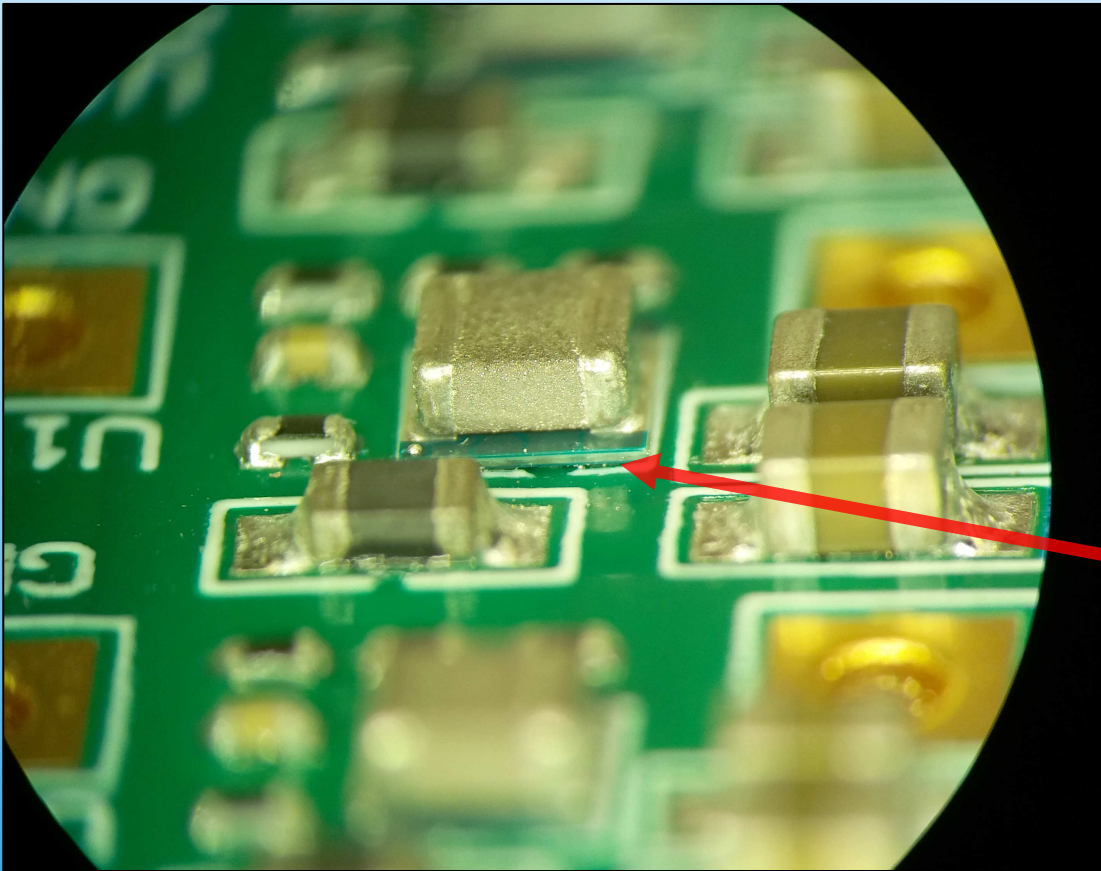
Soldering issues due to uneven solder mask (fixed in-house):

Tilted power-regulators due to uneven solder mask surface

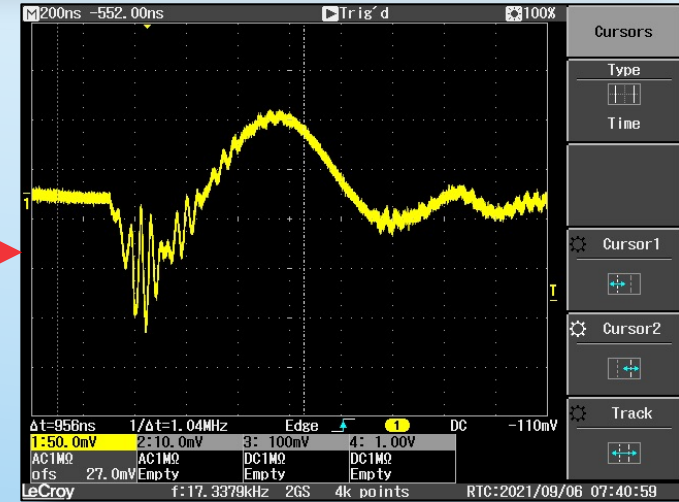
Required voltage stability: < 10mV peak to peak

Not met by original design!

- Sampler reset
- FPGA programming lost

Original power supply

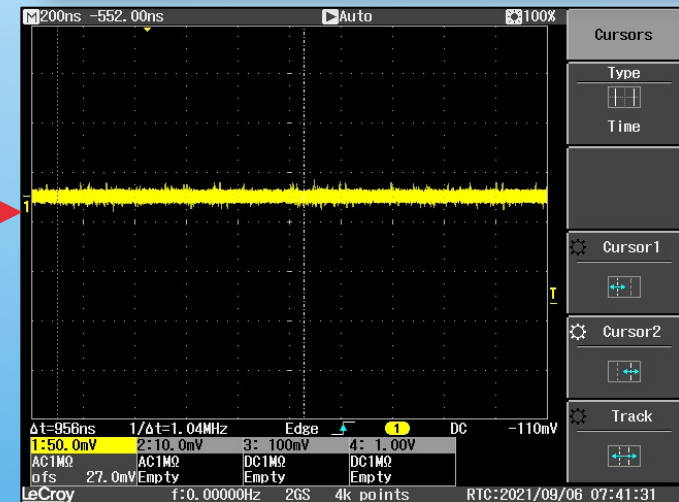
Reworked power supply

Redesign of PCB power supplies

Stable operations of sampler and FPGA after fix
